DEPARTMENT OF TRANSPORTATION

Federal Aviation Administration

[Docket No. FAA-2022-0891; Project Identifier AD-2022-00585-A,E,R; Amendment 39-22432; AD 2023-09-09]

Airworthiness Directives; Various Airplanes, Helicopters, and Engines

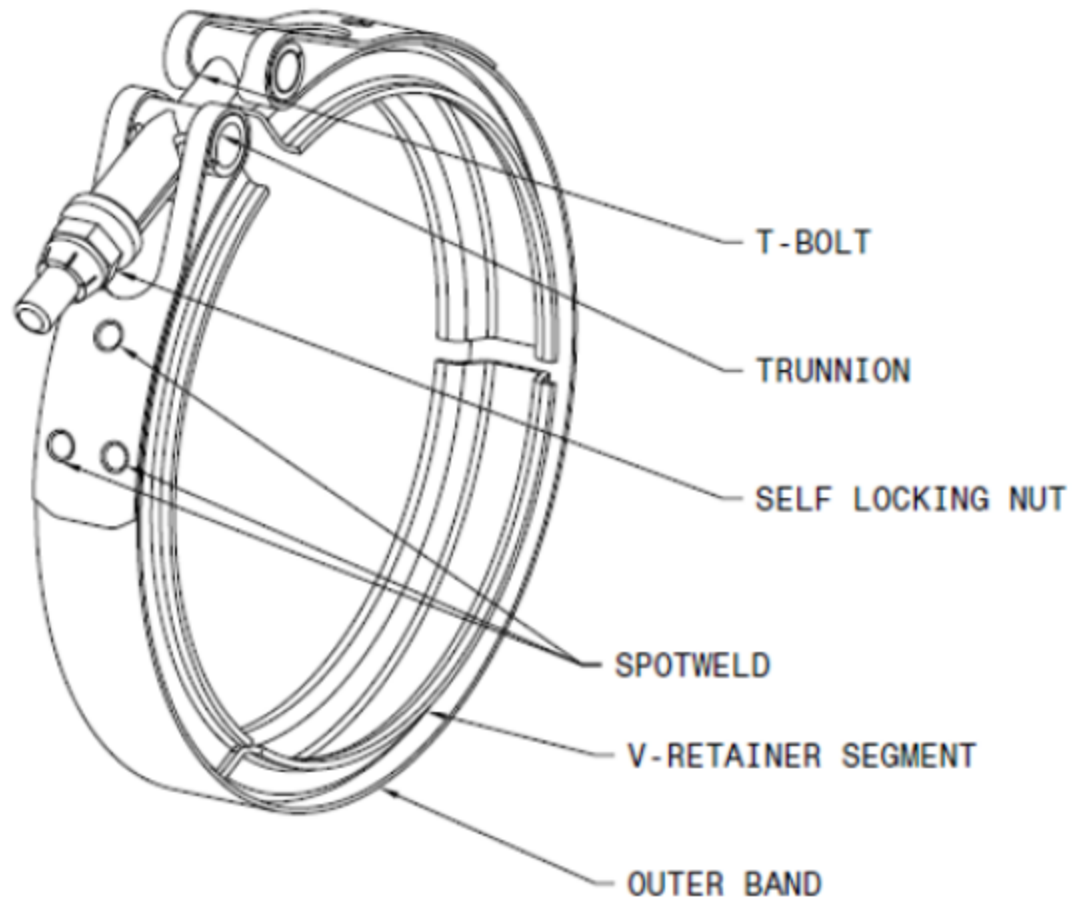
Figure A

The final report concluded that the common denominator in the incidents and accidents reviewed is the spot-welded, multi-segment exhaust tailpipe v-band coupling (see Figure A). These couplings come in either two or three segment varieties. The segments are the number of v-retainer segments, which are attached to the outer band via spot welds. Although multi-segment exhaust tailpipe couplings can also be riveted, the riveted couplings do not create an unsafe condition.

Spot-welded, multi-segment exhaust tailpipe v-band coupling

The majority of the events studied by the working group indicated fatigue failure of spot-welded, multi-segment exhaust tailpipe v-band couplings as a result of stress corrosion cracking that originated at or near a spot weld. This is the same unsafe condition identified in the other v-band coupling AD actions previously referenced. The data studied by the working group contained evidence of pre-existing cracking of the couplings, known embrittlement at the spot weld locations simply due to that manufacturing method, and outer band cupping on the multi-segment couplings (which is the result of age, over-use, and potential over-torquing). The working group also found that many of the couplings had safety wire across the bolt end. The safety wire could be helpful if there was a bolt or nut failure (extremely rare events) or the nut was missing. However, the safety wire was of no value when the failure was transverse band cracking and total separation at the spot weld. The data studied by the working group indicated

This condition, if not addressed, could lead to failure of the spot-welded, multi-segment exhaust tailpipe v-band coupling, leading to detachment of the exhaust tailpipe from the turbocharger and allowing high-temperature exhaust gases to enter the engine compartment. This could result in smoke in the cockpit, in-flight fire, and loss of control of the aircraft. The FAA is issuing this AD to address the unsafe condition on these products.

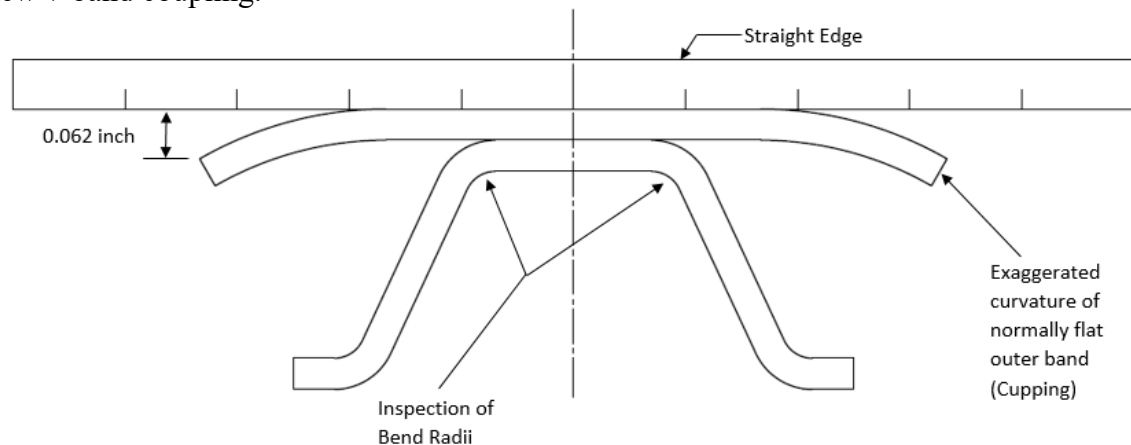
Figure 1 to paragraph (l)(1)(iii) – Inspection Depiction

(iii) Visually inspect the flatness of the outer band using a straight edge. Lay the straight edge across the width of the outer band as depicted in figure 1 to paragraph (l)(1)(iii) of this AD. If the gap between the outer band and the straight edge exceeds 0.062 inch, before further flight, remove the v-band coupling from service and install a new v-band coupling.

(v) Visually inspect the bend radii of the v-retainer coupling segments, throughout the length of the segment, as depicted in figure 1 to paragraph (l)(1)(iii) of this AD, for cracks. If there are any cracks, before further flight, remove the v-band coupling from service and install a new v-band coupling.
